26 August 2022

## **Investigation Report on CLP Cable Bridge Fire Incident on 21 June 2022**

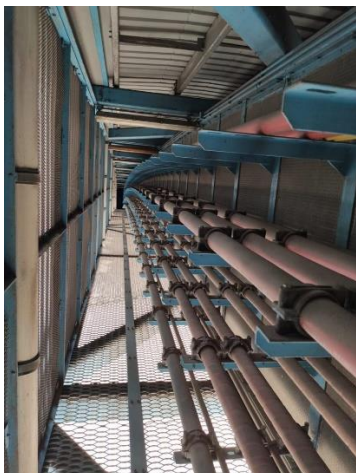
View of Compartment B of the cable bridge, from inside the bridge and looking towards Kwong Yip Street entrance, showing the installation of the 11kV and the disused 132kV now drained oil filled cables (lower layer).

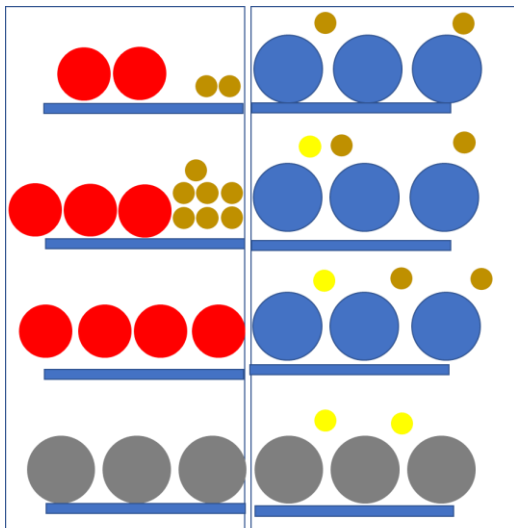
## Attachment 2 : Cable Bridge Installation Layout

- 132kV Cables ● (each circuit has 3 cables)
- 11kV Cables ● (each circuit has 1 cable, and there was a spare cable)
- Fibre Optics Cables ●
- Pilot Cables ●
- Drained 132kV oil filled Cables ●

\*Cable layout based on the best knowledge of available information

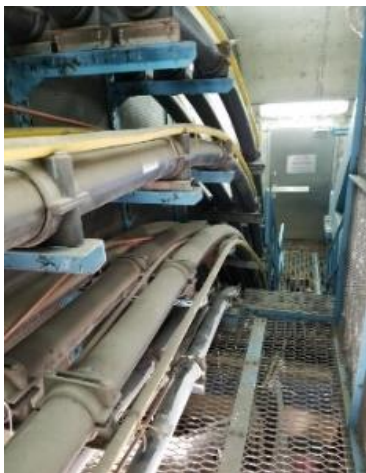
View of Compartment A of the cable bridge, from inside the bridge and looking towards Kwong Yip Street entrance, showing the cable racks on 132kV cables.
